## **Investigations of Coastal Erosion by Means of Laser Scanner VZ-1000 in Vestpynten, Spitsbergen**

The erosion of a coastal bluff was investigated using a Riegl VZ-1000 laser scanner. The bluff is located at Vestpynten (Spitsbergen), where the local road is threatened by erosion of the bluff. The bluff is approximately four meters high. The coastal bluff was scanned three times during the 2012-2013 field season. The resulting point clouds were used to illustrate the change of the surface of the coastal bluff and to calculate the material losses over time. Results can be used when one considers coastal protective measures for the studied area. Recommendations and suggestions regarding routines during field survey and data processing are presented.

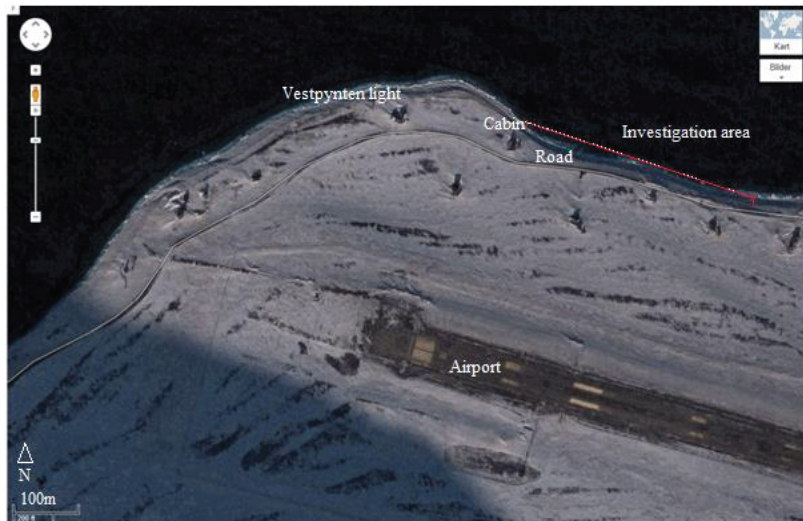
**Figure 2:** Satellite picture of Vestpynten with indicated investigation area and infrastructures (Google 2013).

Due to increasing interest in Arctic coastal regions, coastal erosion is becoming an attractive topic. This paper is a part of Nina Ganicheva's master thesis (2014) and a continuation of the master thesis written by Antonia Linzbach. The work describes the processing of 3D Laser measurements from an eroding bluff in Svalbard, in order to investigate the erosion pattern at the site as a basis for the design of an appropriated shore protection suggestion, as well as to evaluate the applicability of 3D laser measurement systems in Arctic environments. This technology is assumed to be of interest due to its precision, comparably easy set up and the possibility to conduct measurements in inaccessible areas. The measurements were done at Vestpynten, Spitsbergen (Position 78.25209N 15.41691E) in 2012 and 2013, where several infrastructures are located closely to an eroding bluff (Figure 1, Figure 2).
